ROM Bin Brow Repair Redesign and Installation

Commodity:
Gold

Location:
New South Wales

Service:
Engineering Design, Fabrication and Site Installation

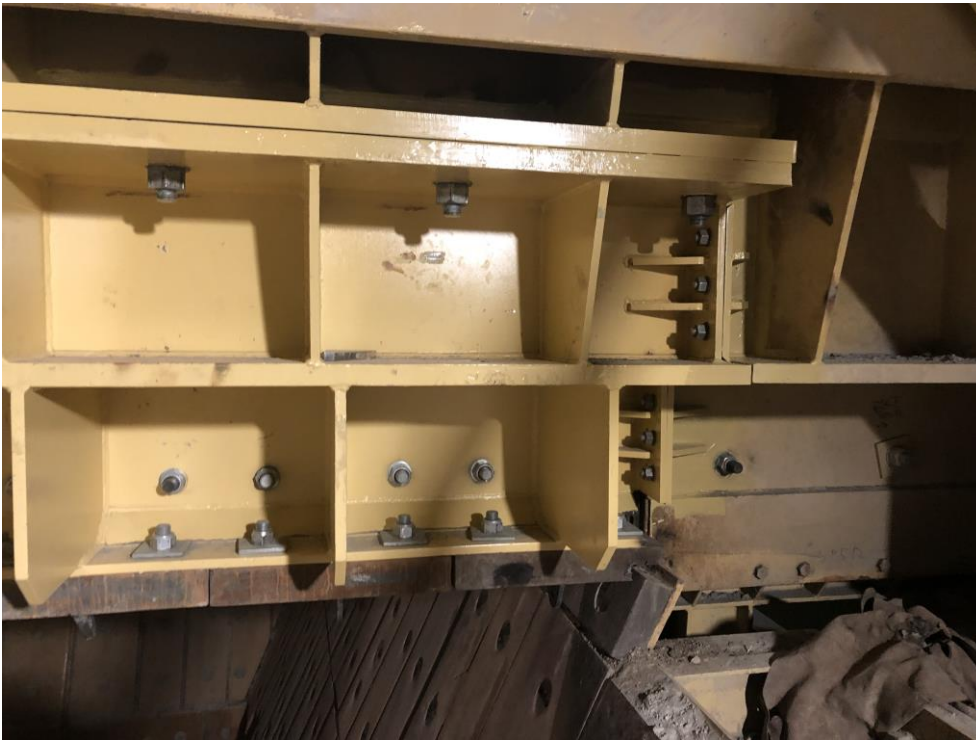
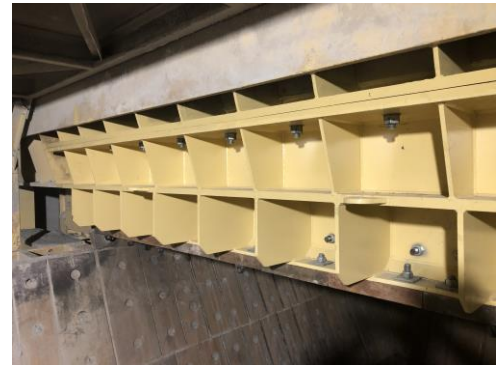
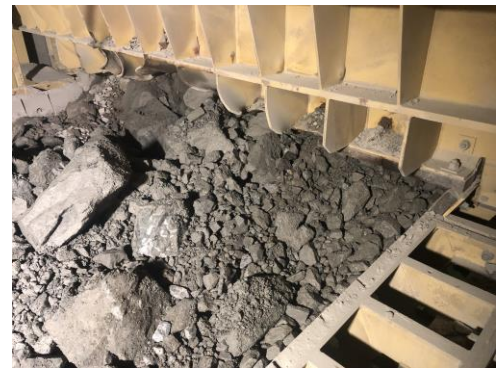
Forefront Services was engaged to carry out repairs to the lower front area of a ROM bin brow. The parent metal had worn away and required significant in situ repairs. The proposed repairs included cutting out the plate and gusset sections then fabricating sections on site for welding back into place. This method of repair meant many hours of cutting then fabrication and welding in the replacement sections. All of this carried out in the underground environment.

Upon review of the work required, Forefront suggested to change the methodology and rather than carry out the in-situ repairs, a single replaceable lower section was designed and fabricated for installation. This replaceable section meant the in-situ requirement was only a single flange and a small section of internal plate. This reduced the requirement for onsite cutting and welding by at least 75% thus minimising hot works and fabrication underground. Having a replaceable section also allows for easy replacement in the future should the same level of damage occur again.

- Design and engineering of the replacement brow.
- Manufacturing drawings and fabrication of the replacement brow section.
- Surface treatment (blast and paint in accordance with client specifications)
- On site installation
